AI-III-C-056 Carleton Farm
Rt. 40
Cumberland vicinity, Allegany Co. MD
Not Eligible

INVENTORY FORM FOR STATE HISTORIC SITES SURVEY

HISTORIC
Carleton Farm

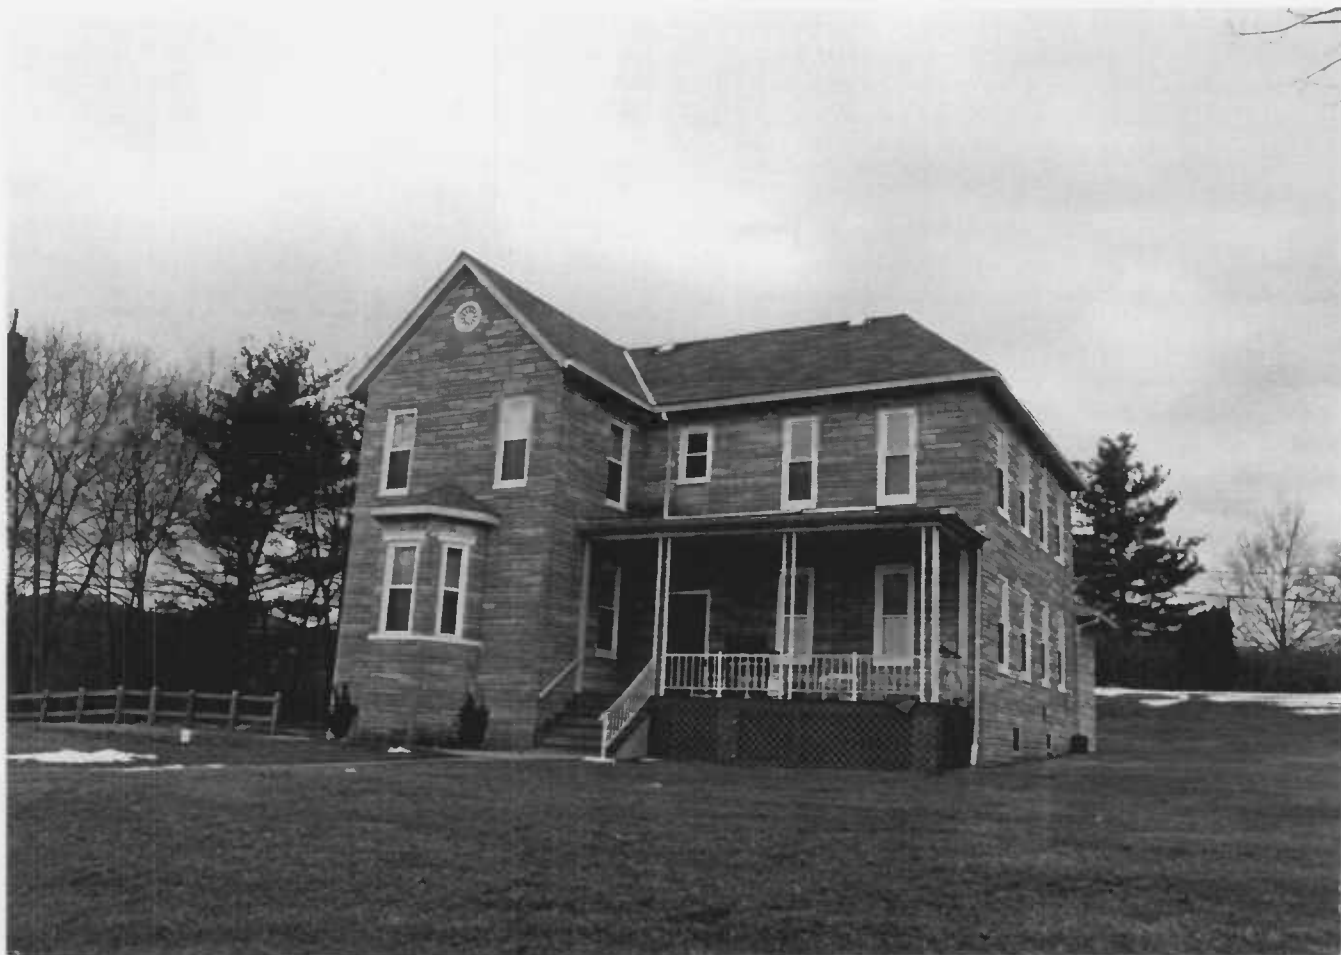
View of Carleton Farm (A1-III-56).

This north-facing two-story house includes a gabled section to the east and a hip-roofed section to the west. The entire building is clad in PermaStone. Asphalt shingles cover the roof and 1/1-sash windows light the building. The gable end of the two bay by five bay eastern section faces front and projects from the western section. A bay window is centered on this end. A porch covers the first story of the three bay by four bay western section of the house. Most of the porch materials appear to date from the mid 20th century.

This house appears to date from the early 20th century. As modern materials have altered the appearance of the structure, it is recommended as not eligible for the National Register of Historic Places.

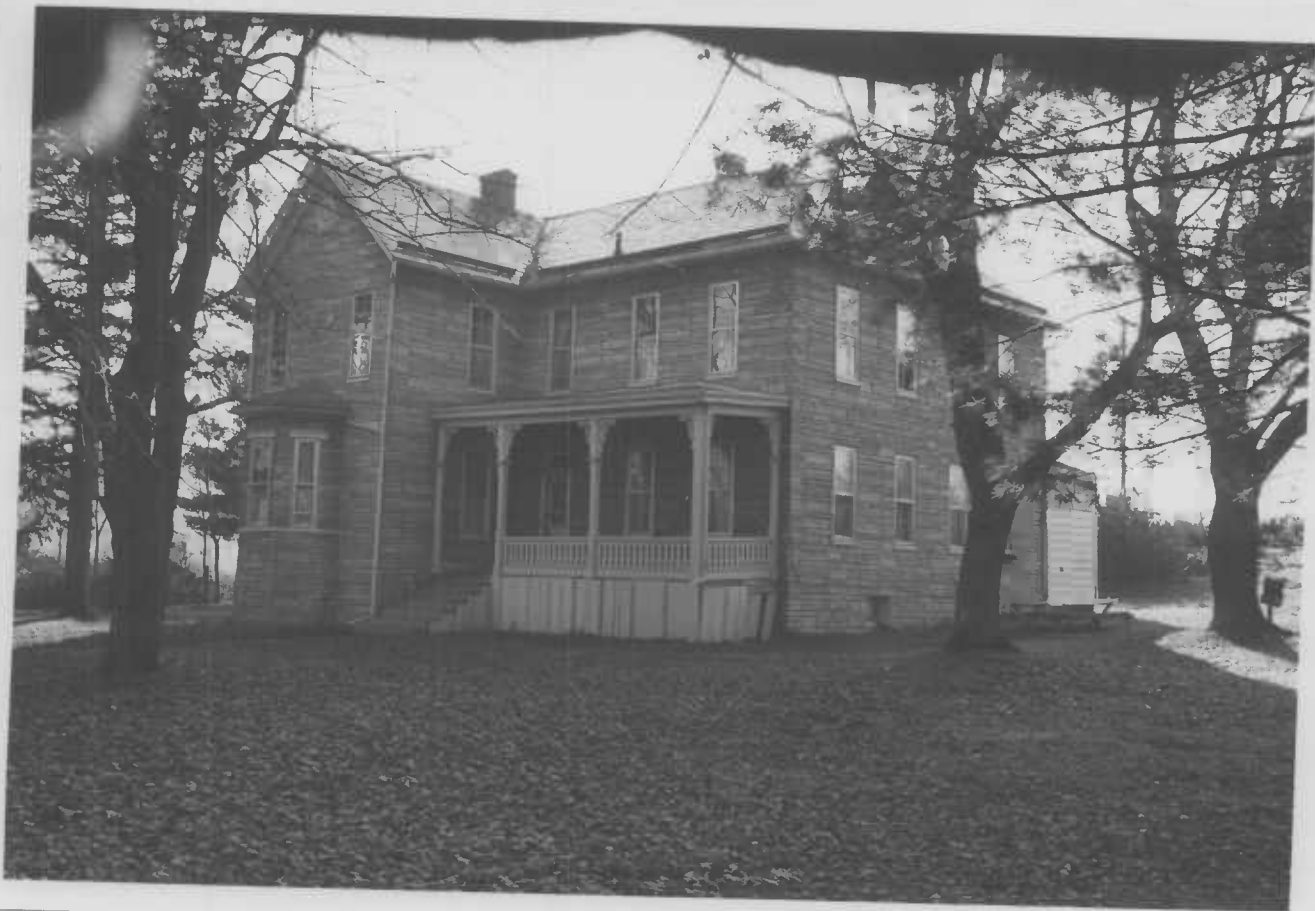
VIEW FROM NORTHWEST

This unusually large 2 1/2 story frame house faces north. Its "L" form results from the intersection of a three bay wide, four bay deep hip-roofed block and a two bay wide, five bay deep gable roofed section. The whole is clad in perma stone and the roof is covered with slate. All windows are tall, narrow 4/4 sash except those in the projecting three-sided bay on the north facade, which are 1/1. A hipped dormer on the west slope of the main roof lights the half-story. A one-story, half-hipped porch with chamfered posts and scrollwork brackets and balustrade fills the crook of the "L", sheltering the main entrance in the easternmost bay of the main block. A two pane transom appears over the front door.
